High-Temperature Corrosion Observed in Austenitic Coils and Tubes in a Direct Reduction Process

The subject of this study is related to the performance of austenitic steel coils and tubes, in a range of temperatures between 425 and 870 °C for the transport of reducing gas, in an installation involving the direct reduction of iron-ore by reforming natural gas. Evidence is presented that metal dusting is not the only unique high-temperature corrosion mechanism that caused catastrophic failures of austenitic 304 (UNS S304 00) coils and HK-40 (UNS J94204) tubes. Sensitization as well as stress corrosion cracking occurred in 304 stainless steel coils and metal dusting took place in HK-40 tubes, a high resistance alloy. The role of continuous injection of H₂S into the process is suggested to avoid the high resistance metal dusting corrosion mechanism found in this kind of installation.

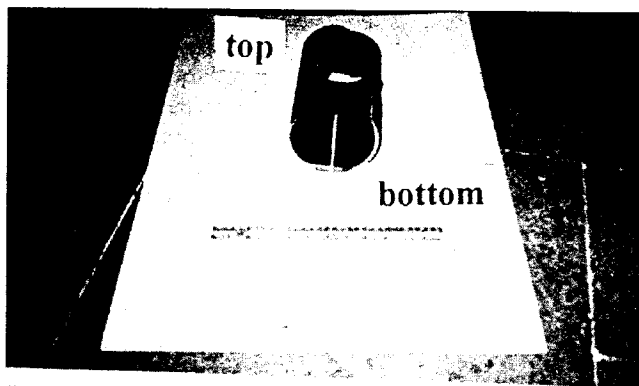
2a

Figure 2(a) shows a section of a 304 stainless steel coil, which was located in the middle of the coil (section CC-104 of Fig. 1, $T \approx 650^\circ\text{C}$), where a hole bigger than 10 cm in diameter was observed

in the upper part of the coil after the catastrophic failure occurred). It is important to mention that holes with diameters smaller than 5 cm were also observed along the total length of the coil, and the holes were always positioned on the top part of the coil. Figure 2(a) shows a transverse section of the coil. On the bottom of the coil, it was observed that its wall thickness was bigger (1 cm) than that of the original centrifugally cast tube (0.5 cm). It can be observed from the bottom to the top of the coil that the wall thickness decreased until failure occurred.

Fig. 2 (a) Transverse section of a 304 SS coil located in section CC-104 A, removed after a catastrophic failure. (b) Longitudinal section of a 304 SS coil located in section CC-104 A, removed after a catastrophic failure. The length of the ruler is 30 cm.

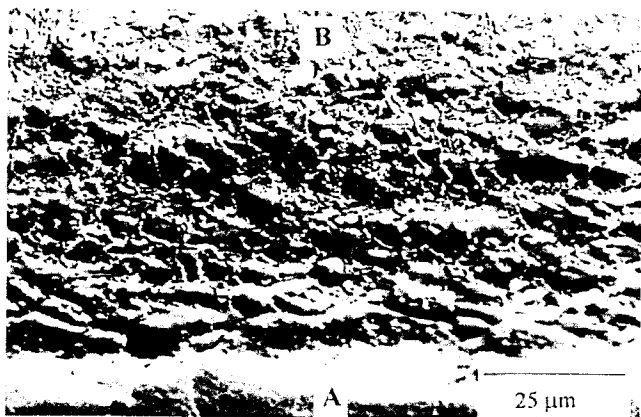
Figure 3 shows a transverse optical photomicrograph of the exploded coil of Fig. 2. The region marked A corresponds to the microstructure observed in areas close to the outer diameter of the coil, which basically shows a microstructure of austenitic grains and no sign of any kind of high-temperature corrosion. The region marked B shows the microstructure in areas close to the inner diameter of the coil. It can be observed how the high-temperature corrosion phenomenon, known as sensitization, is present; in this phenomenon, the grain boundaries rich in chromium precipitates formed a continuous layer. Figure 4 shows the microstructure observed in the thickest section of the pipe of Fig. 2, which consisted of deposited material from dissolution of the sensitized grains at the top of the coil. The white areas are rich in Fe and Cr and the black areas are rich in Fe and Ni, as detected by SEM microanalysis. By optical observation,

Fig. 3 Optical micrograph of the exploded coil of Fig. 2. The section marked A corresponds to areas that do not show evidence of sensitization (close to the outer diameter). The section marked B shows evidence of sensitization (close to the inner diameter of the coil). 1000X

it can be stated that this morphology was due to the slow dissolution of grains located in the upper section of the coil. This dissolution of the sensitized grains (which explains the observation of a very thin wall on the top of the coil and a very thick section

on the bottom) results in a thick section at the lowest part of the coil, as the dissolved grains are deposited (by gravity) to the bottom of the coil.

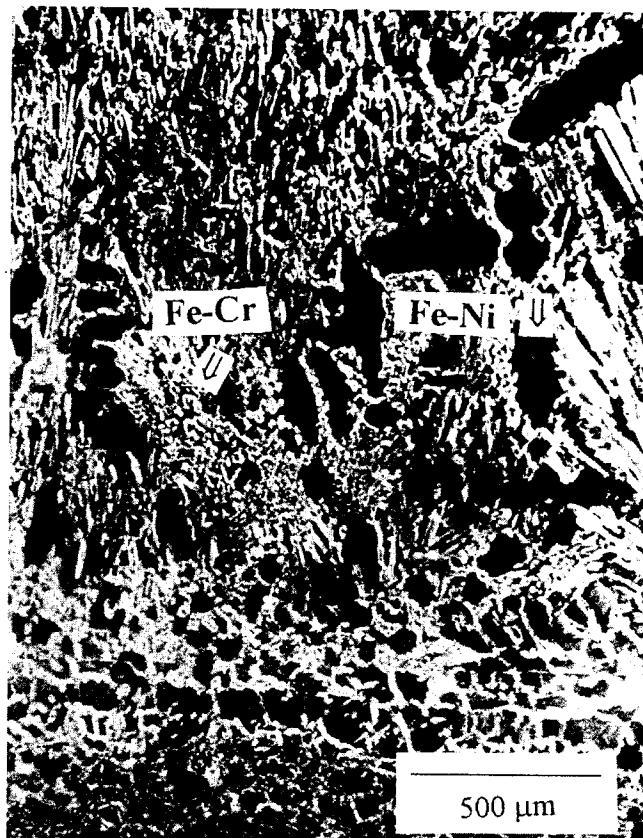
Fig. 4 Microstructure observed in the thickest section of the coil, where material was deposited from the upper part of the coil. The deposit region is denoted Fe-Ni and Fe-Cr. 50X

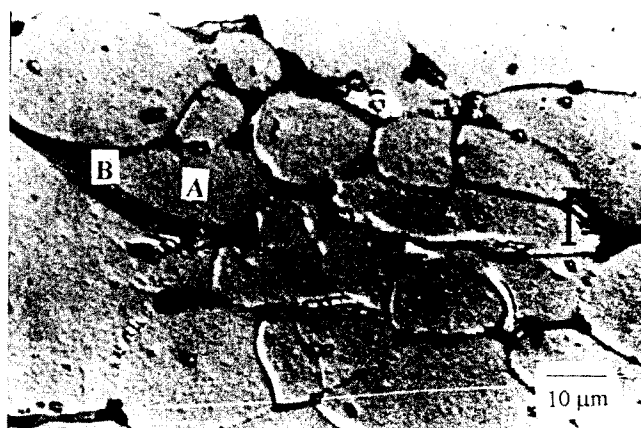
Fig. 5 Microstructure of a 304 SS coil, where depletion of chromium was detected at the grain boundaries. In point A, 18wt% Cr was detected, and in point B, 15wt% Cr was found.

Microanalysis of the sensitized austenitic grains shows a depletion of chromium. For instance, at point A of Fig. 5, the amount of Cr decreased from 18 to about 15 wt.% close to the grain boundary (point B). Figures 6(a) and (b) show the map-

As these precipitates form, local depletion of both Cr and C occurs in the parts of the grain close to the boundary, as shown in Fig. 5. In this specific case, the sensitized process occurs when the 304 stainless steel coils are heated to a temperature close to 650 $^{\circ}\text{C}$, the operating temperature of the second stage of the preheating zone of reduction gases in heater 3. When the heater is occasionally shut down for maintenance, the 304 stainless steel coils are cooled slowly over a period of 48 h from 650 $^{\circ}\text{C}$ to room temperature. It is important to mention that this sensitization phenomenon has only been observed in coils located in the second stage of the preheating zone (CC-104) at a temperature close to 650 $^{\circ}\text{C}$. However, despite the presence of traces of sulfur, no other kind of corrosion mechanism was detected.

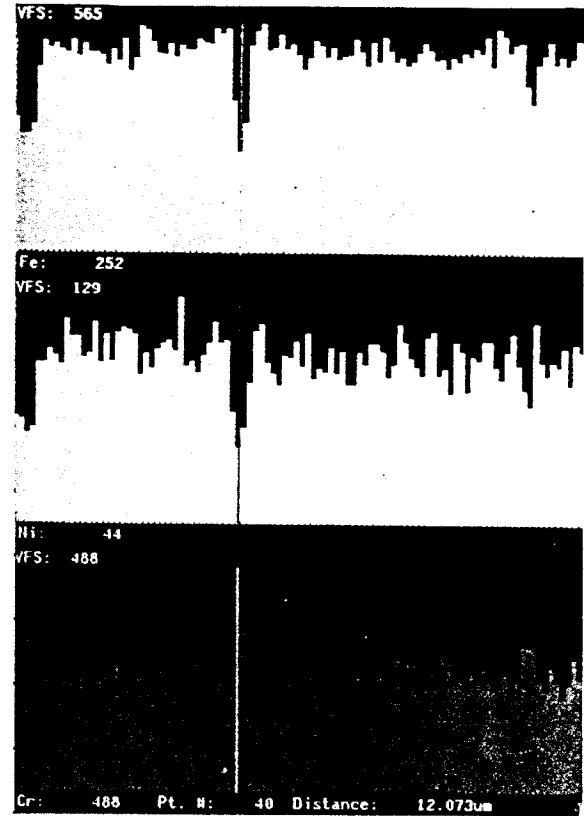
ping and line scans of elements, respectively. It can be observed that Cr is concentrated at grain boundaries and in regions where slip bands are present. Experimental evidence of this phenomenon is shown in Fig. 6(c), where it can be observed that in intergranular spacing, there is a detachment of particles in which avoid of about 10 to 20 μm is present, causing the intergranular corrosion of stainless steels as a result of the precipitation of carbides of the type Cr_{23}C_6 (as identified by mapping and line scans) in the intergranular region and a corresponding depletion in the chromium content.

Fig. 6 (a) SEM mapping of chromium in a 304 SS coil. (b) SEM line scan analysis of Cr, Fe, and Ni. (c) Microstructure of a 304 SS coil, where there is detachment of particles in which voids are present (arrow shows the position where particles were detached leaving voids).

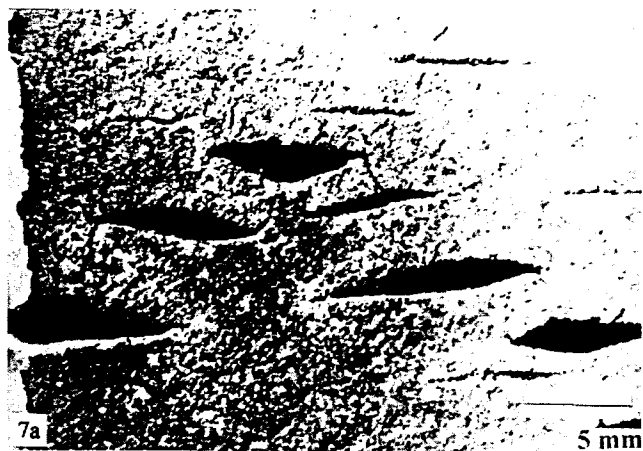
Figure 7(a) shows a series of elongated rhombohedral cracks located on the inside wall of the coil of section CC-105A. Figure 7(b) shows a transverse section of the cracks, which are stress corrosion cracks that run along the grain boundaries. Figure 7(c) shows another area of the grains affected by stress corrosion cracking. Figure 8 shows an x-ray diffraction pattern of the corrosion products removed from the inside wall of the corroded coil. The identified species were Fe_3O_4 and FeS, as a corrosion product is due to some sulfur

being present in the reducing gases, which suggests that the corrosion process of stress corrosion cracking is accelerated by the presence of this element.

Fig. 7 (a) Elongated rhombohedral cracks are observed in the inside wall of the coil located in section CC-105 (section B, Fig. 1). (b) and (c) The microstructure observed in transverse sections of the rhombohedral cracks. Both at 500X

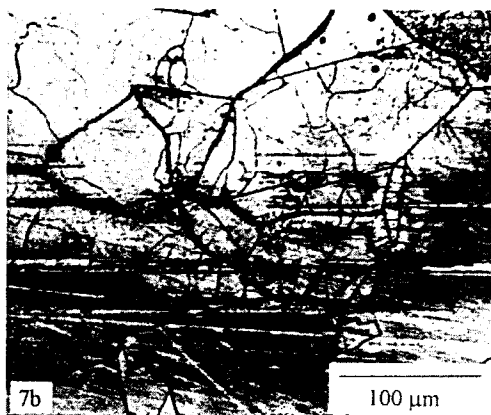
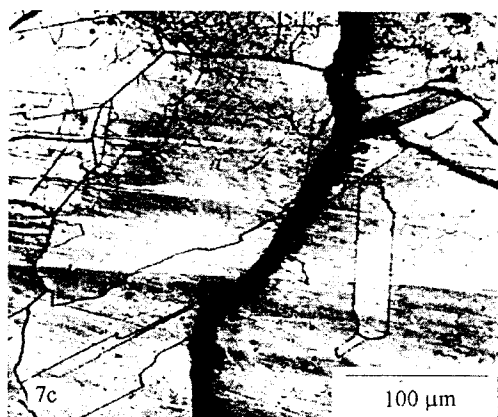
tinuous protective scales of chromium sesquioxide under certain conditions, resulting in a discrete presence of sulfide precipitates immediately beneath the protective oxide scales. In our case, FeS can be detected by x-ray diffraction, which allows the presence of the assumption that this sulfide is the product of an accelerated attack caused by a rich amount of sulfur present in the gas (about 4 to 7 ppm of S).

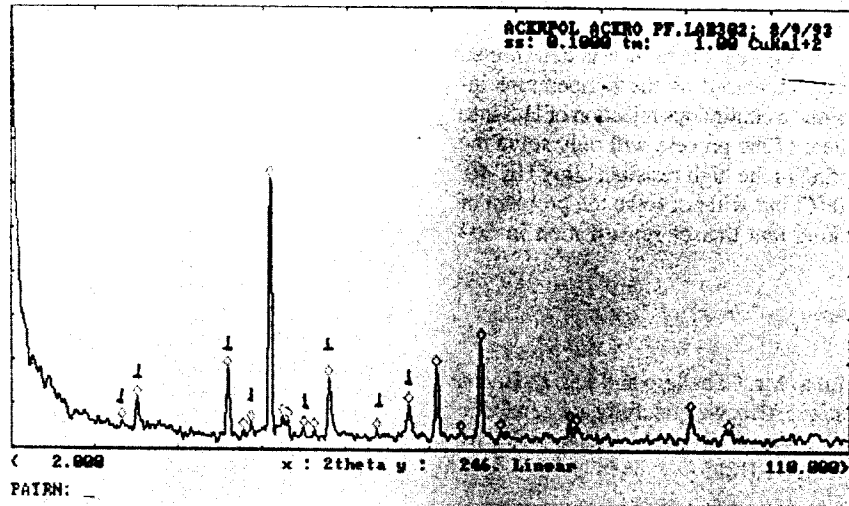
Fig. 8 X-ray diffraction pattern (counts per second: cps vs KeV) of corrosion products removed from the inside wall of a 304 SS coil section CC-105 (section B, Fig. 1). Peak notations are 1 = FeS; others are Fe₃O₄.
