Failure analysis of a gas turbine blade made of Inconel 738LC alloy

The failure analysis of the 70 MW gas turbine first stage blade made of nickel-base alloy Inconel 738LC is presented. The blades experience internal cooling hole cracks in different airfoil sections assisted by a coating and base alloy degradation due to operation at high temperature. A detailed analysis of all elements which had an influence on the failure initiation was carried out, namely: loss of aluminium from coating due to oxidation and coating phases changing; decreasing of alloy ductility and toughness due to carbides precipitation in grain boundaries; degradation of the alloy gamma prime (γ') phase (aging and coarsening); blade airfoil stress level; evidence of intergranular creep crack propagation. It was found that the coating/substrate crack initiation and propagation was driven by a mixed fatigue/creep mechanism. The coating degradation facilitates the crack initiation due to thermal fatigue.

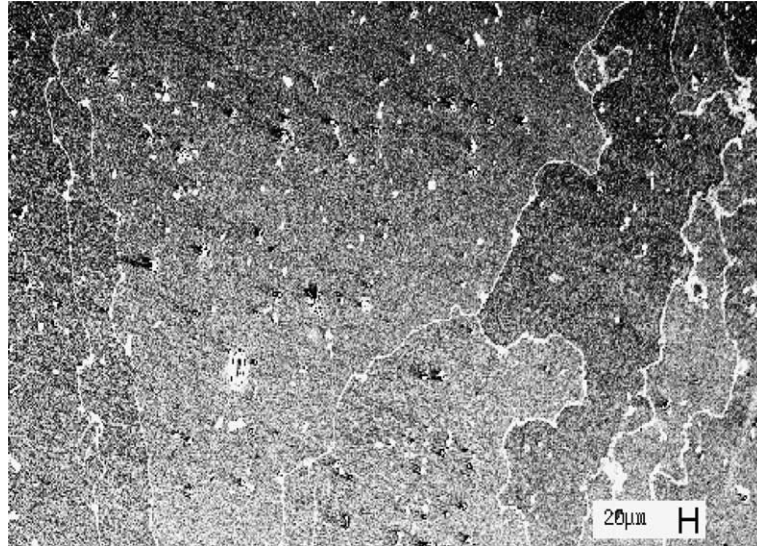
Samples for microstructural evaluation were taken from the blade airfoil hottest zones as indicated in Figs. 1–3. The hot gas flow trace on the blade airfoil (oxidation pattern) corresponds to the hottest zones of the blade (see Figs. 1 and 2). In Fig. 8 the microstructure of a sample taken from zone 5 (see Figs. 2 and 3) can be appreciated after electro polishing. The microstructure consists of grains of γ and carbide particles precipitated in the matrix and grain boundaries. The average grain size was determined to be 560 μm . In grain boundaries was found a continuous film of carbides of 1.5–3 μm thickness approximately. In Fig. 9 is shown the detail of a continuous film of carbides in grain boundaries. As a result of transformation of carbides of MC type to $M_{23}C_6 + \gamma'$ type during operation at high temperature, the volume fraction of MC type carbides in grain boundaries was 5% and $M_{23}C_6$ type was 95%. These values are very different to those in the blade root. In Figs. 9–11 showed the presence of γ' particles with considerable degree of deterioration.

Fig. 8. Grain size and carbide particles precipitated in the matrix and grain boundaries of the blade airfoil zone 5 – from Figs. 1 and 3.

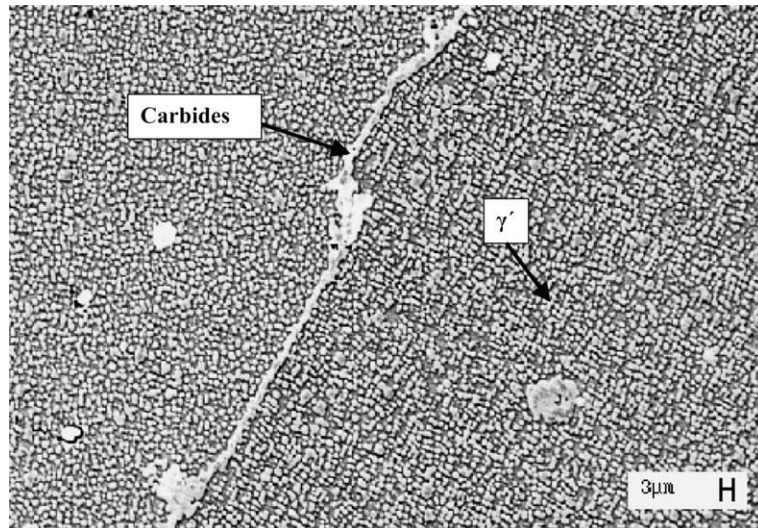
Fig. 9. Continuous band of grain boundary carbides and γ' morphology in the zone 5.

Substrate grain boundary crack initiation and propagation together with the presence of small creep voids on the intergranular facets of the tip of the crack is evidence of a creep failure mechanism. This is supported by the stress distribution. The predicted airfoil maximum stress location on the internal cooling hole surface is consistent with the crack location. Substrate crack initiation and propagation is facilitated also due to grain boundary brittleness [8] caused by the formation of a grain boundary continuous film of carbides as mentioned before (see Fig. 9).

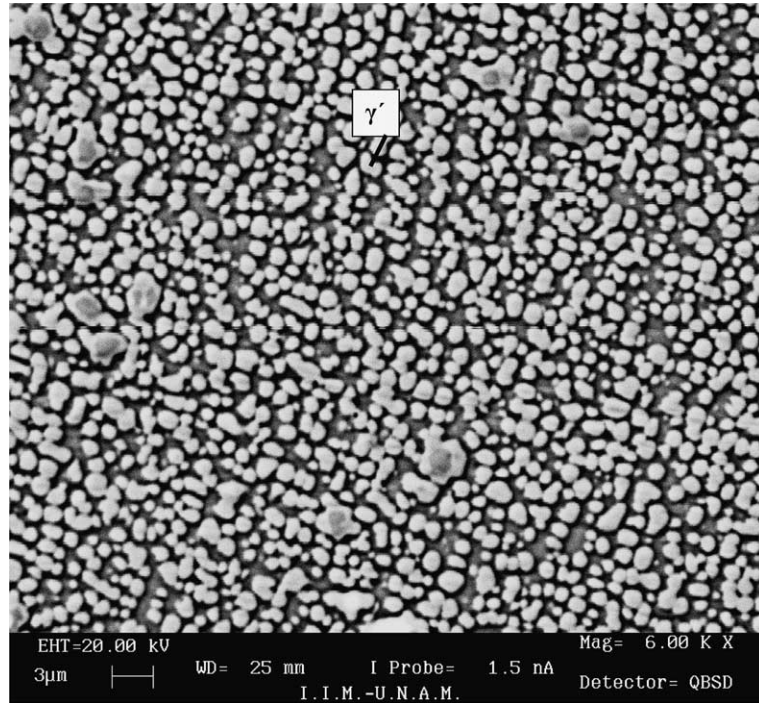
The γ' original cubical shape changes into elongated platelets (rafts) oriented perpendicularly to the principal stress direction. After a certain time the γ' elongation reaches an equilibrium state where no further elongation takes place. Also, the coalescence (growing) of γ' particles is observed. The time to reach the equilibrium state is stress and temperature dependent so that the time to reach the maximum γ' raft length decreases with increased temperature and/or stress. The final equilibrium γ' raft length also differs, depending on applied stress and temperature level. The γ' elongation in nickel-base alloys is related to gradual decrease of the total blade life [5–7]. For the Inconel 738LC blade, the γ' elongation was quantified by measuring the length/width ratio (R ratio) for approximately 8000 γ' particles. Each particle was measured in an elliptic projection of D_{\max} (length) and D_{\min} (width). The average was calculated using a computerized image analysis system. The average size of γ' particles (D_{\max}) in zone 5 (see Figs. 2 and 3) was 1.3 μm

(Fig. 10) and the average elongation/rafting (length/width ratio) 1.8. The γ' volume fraction in the measured area was 42%.

Fig. 10. Gamma prime (γ') morphology in the zone 5.

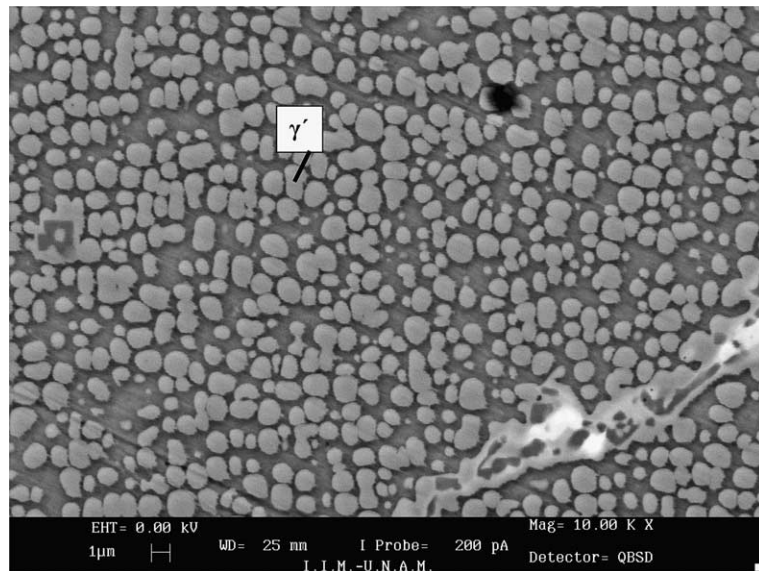
Fig. 11. Gamma prime (γ') morphology in the zone 3.

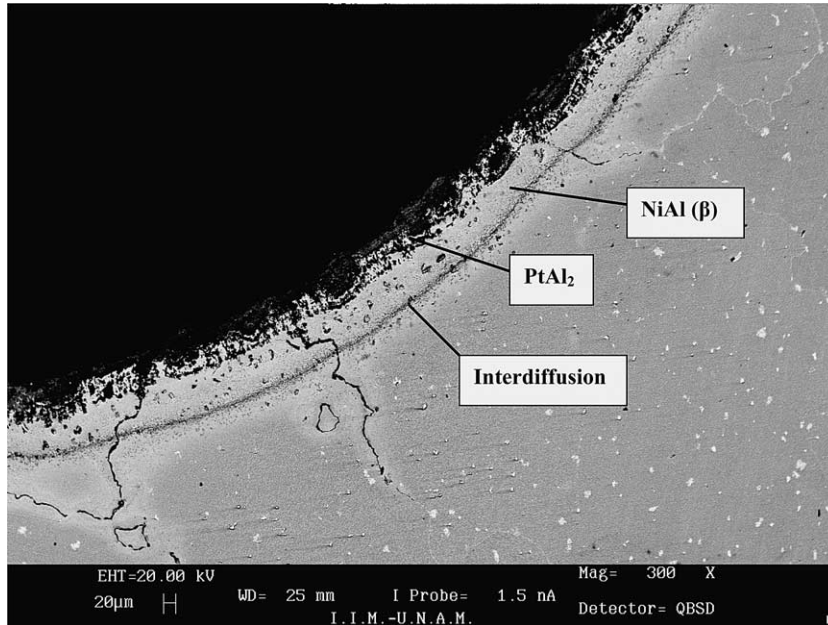
Fig. 12 shows coating deterioration in internal cooling holes of the airfoil. Loss of the coating constituents due to oxidation can be seen. The thickness of coating in different airfoil transversal sections (zones) is shown in Table 2. Using the same method all blade airfoil zones (1–6 indicated in Figs. 1–3) were metallographically evaluated. A similar tendency of microstructural transformation was found but with some variation of degree of alloy deterioration from zone to zone related to blade temperature variation in

The cracks in the internal cooling holes in the hottest sections of the blade (airfoil central sections) were detected (see Fig. 12). Cracks initiate in the cooling hole coating and propagate into the substrate following grain boundary trajectories. The crack size reaches 0.4 mm. At the crack tip, small creep voids were iden-

Fig. 12. Thermomechanical fatigue cracks in the cooling holes.

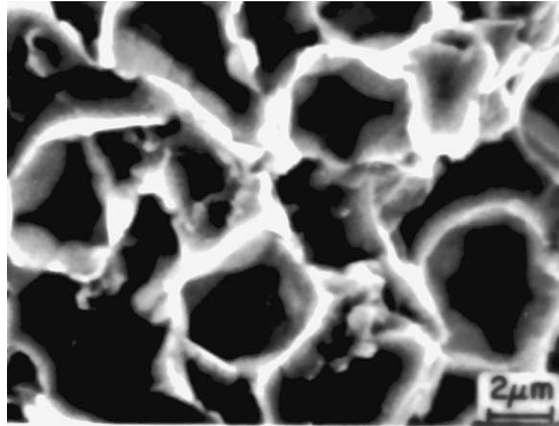
tified on the intergranular facets at the extreme tip of the crack (Fig. 13). On the basis of these evidences it was evaluated that the crack initiation/propagation was derived by a mixed fatigue/creep mechanism. The coating crack initiation was probably due to a thermal fatigue mechanism as a result of high thermal transient loads (trips, start-ups and slow-downs), and crack grain boundary initiation and propagation in the substrate by a creep mechanism (high steady state load).

Fig. 13. The small creep voids identified at the extreme tip of the crack.

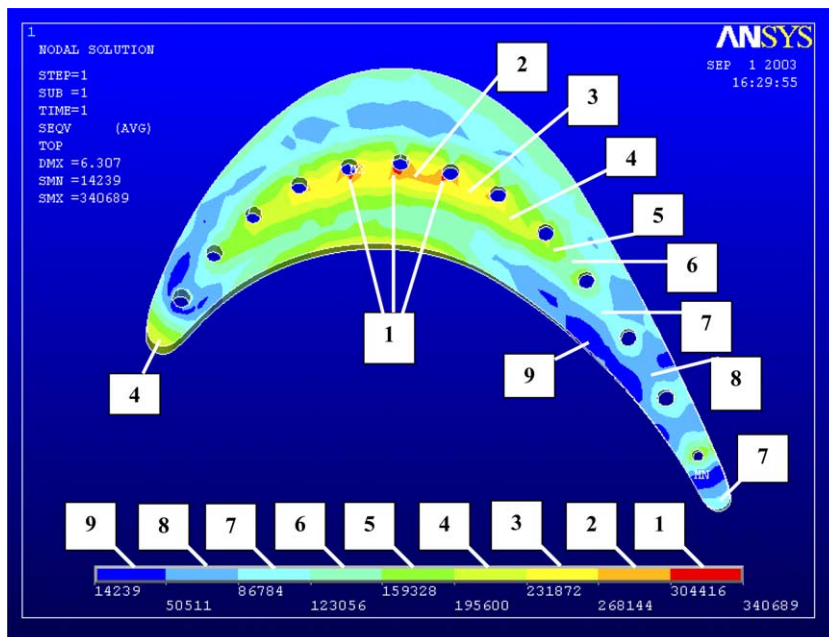
Thermomechanical stress analysis was carried out on the first stage blades by means of the finite element method (FEM) using the commercial code ANSYS. The maximum tension stresses in the blade airfoil were approximately 341 MPa (see Fig. 14) and were located in the cutting plane at 60% vane height on the cooling hole surface. The stresses were principally thermal stresses developed due to high temperature gradients across the airfoil wall (between vane external surface and surface of internal cooling holes). A very good agreement of the predicted stress distribution and crack location can be seen.

Fig. 14. Blade airfoil stress distribution in the cutting plane at 60% vane height.
