CHEMICAL AND PHYSICAL CHARACTERIZATION OF STUCCOS FROM A MEXICAN COLONIAL BUILDING: EL MUSEO DEL CALENDARIO OF QUERETARO*

KEYWORDS: STUCCO, CHARACTERIZATION, HERITAGE PRESERVATION, RESTORATION, LIME

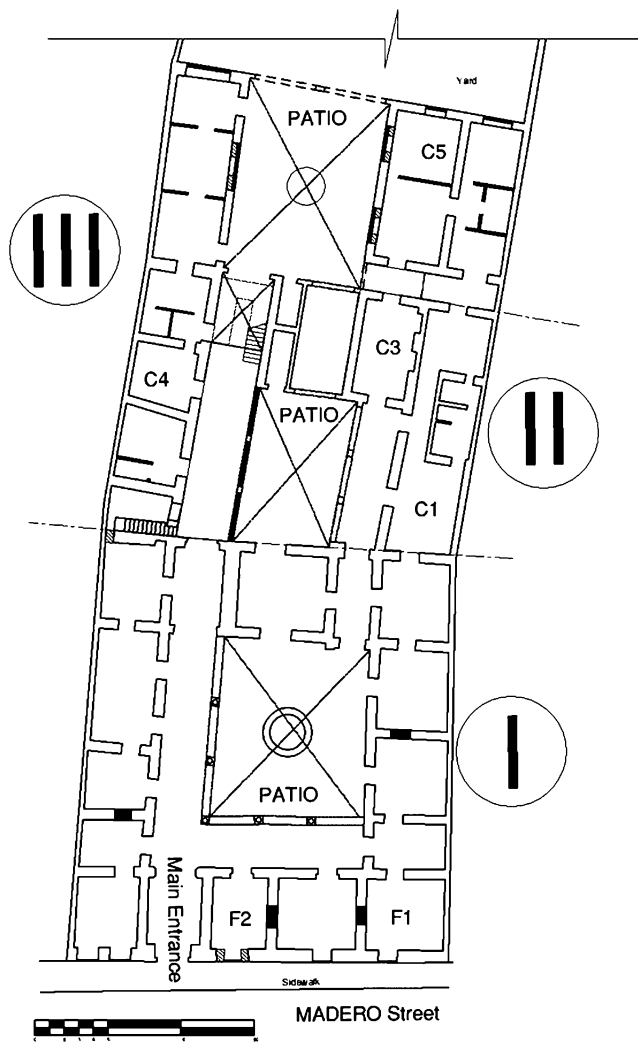
Figure 2 Layout of El Museo del Calendario. The rooms where samples of different stuccos were taken are indicated.

In order to obtain a complete identification of all mineral components incorporated in stuccos and mortars, six stucco samples were taken from three different locations of the house, corresponding to the three construction phases, and studied (see Fig. 2). Samples F1 and F2 correspond to stage I, samples C1 and C3 to stage II, and C4 and C5 to stage III. The samples collected weighed approximately 250 g and were gathered from selected sites of these walls where no prior interventions had been made. These were stored in sealed bags for later analysis. The exterior surfaces of the locations where each of the stucco samples was taken were removed because they contained a coloured layer.

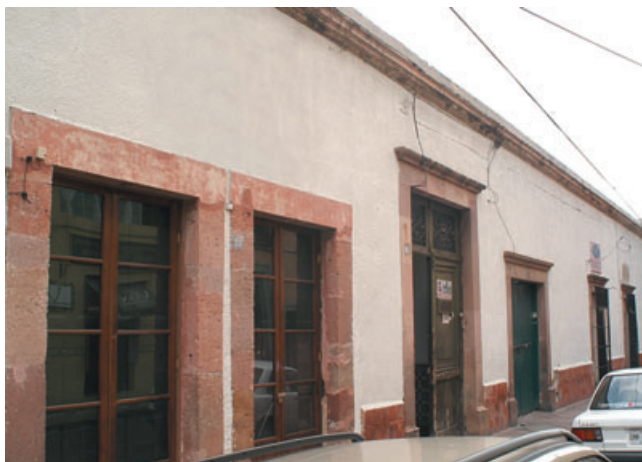
Figure 3 Photograph of the frontage of El Museo del Calendario, showing the conservation state before the restoration process.

The front of the building prior to the intervention can be seen in Figure 3. Regardless of the preserved appearance, the main wall had several damaged areas of separated stuccos and large cracks along the top of the walls. In addition, the main door was in an advanced state of deterioration. The particular surroundings of the building can be observed at the top of the Figure 4. Some rooms, corridors and part of the patio of stage I, are included in the image.

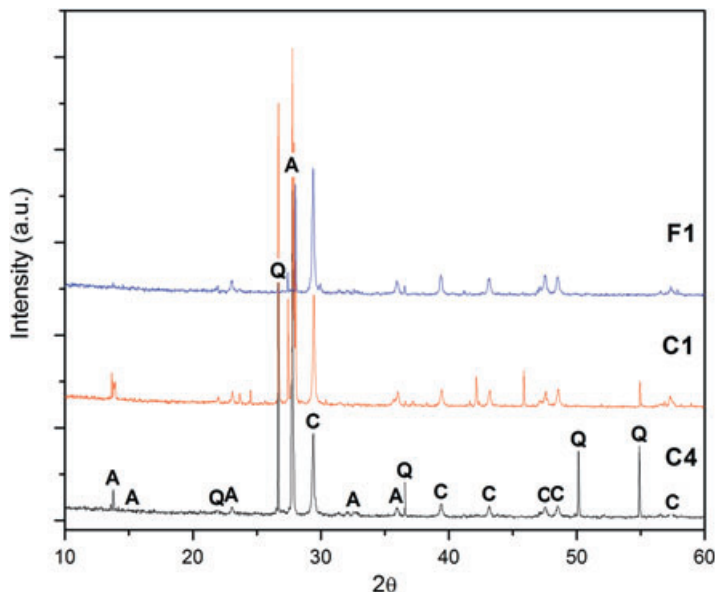
Figure 5 X-Ray diffraction patterns of samples C1, C4 and F1. The main constituents were identified as albite (A), calcite (C) and quartz (Q).

Figure 5 shows the X-ray diffraction patterns of the stucco samples from the three different building stages. In all the samples the same constituents were detected. However, of these samples only three were chosen as part of the investigation. The crystalline structures found in sample F1 (stage I), correspond to quartz (SiO_2), albite [$\text{Na}(\text{AlSi}_3\text{O}_8)$], and calcite (CaCO_3),

identified according to the International Centre for Diffraction Data Cards 03-065-0466, 01-071-1150, and 00-0050586, respectively. The presence of quartz was evidence of the use of sand in the formulation of the original stucco; albite makes known the use of pozzolan. Calcite was found instead of $\text{Ca}(\text{OH})_2$ which is indicative of the prior use and later chemical transformation of the lime. In the X-ray pattern of sample C1 (corresponding to stage II), quartz (SiO_2), albite [$\text{Na}(\text{AlSi}_3\text{O}_8)$], and calcite (CaCO_3) were found. Once again the use of sand, pozzolan and lime were confirmed. Sample C4 from stage III exhibits the presence of the same compounds as those of C1. $\text{Ca}(\text{OH})_2$ was not found in any of the samples because of the continuous interaction between lime and CO_2 in the environment, which produces CaCO_3 via the carbonation processes (Galván-Ruiz *et al.* 2007).

Comparing the patterns seen in Figure 5 it is feasible to suggest that this building had in fact at least three different constructive stages, which also means that three different kinds of stucco were used. Taking into account the results shown in Figures 5 and 6, the main components in the stuccos are: sand, lime and pozzolan. Nevertheless, it is possible that other non-crystalline materials could be present.

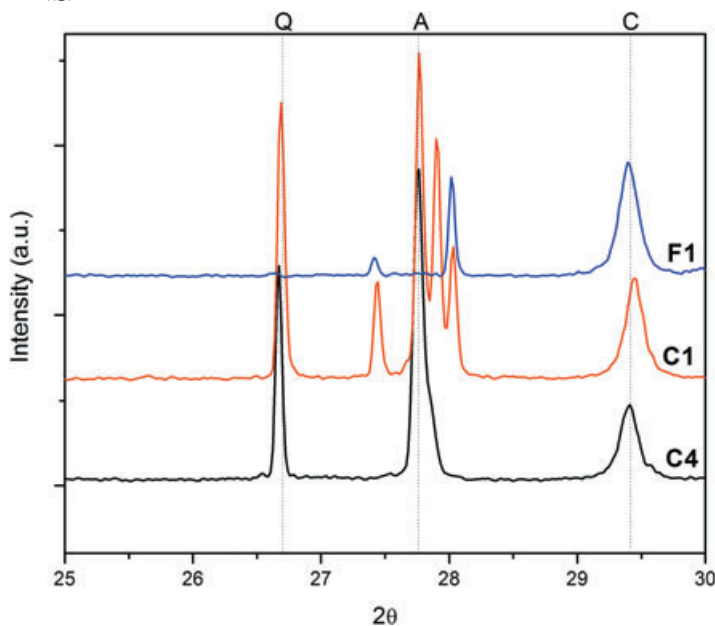
Figure 6 Amplified 2θ regions show details of the signals from quartz (Q), albite (A) and calcite (C), allowing a comparison of relative intensities.

The amplifications in the diffractograms in the range from 25° to 30° in 2θ , show in detail the peaks at 26.68° , 27.78° and 29.4° which correspond to the largest intensity signals of quartz, albite and calcite, respectively (Fig. 6). The relative intensities of those signals are related to their corresponding concentration in the stuccos. By comparing the intensities it is possible to

establish that the samples are rich in sand and pozzolan in relation to the calcite content. The signals at 27.4, 27.9 and 28° correspond only to albite.

A few small differences can be also observed in Figure 6; the most evident is the presence of three signals corresponding to albite in sample C1 and just one of these signals in F1 and C4 samples. This could be because the albite in C1 had a random crystal growth, whereas in F1 and C4 albite had crystal structures with preferential orientations. In addition, the quartz content in F1 is less than that in C1 and C4, but the presence of the mineral in F1 was confirmed in Figure 5.

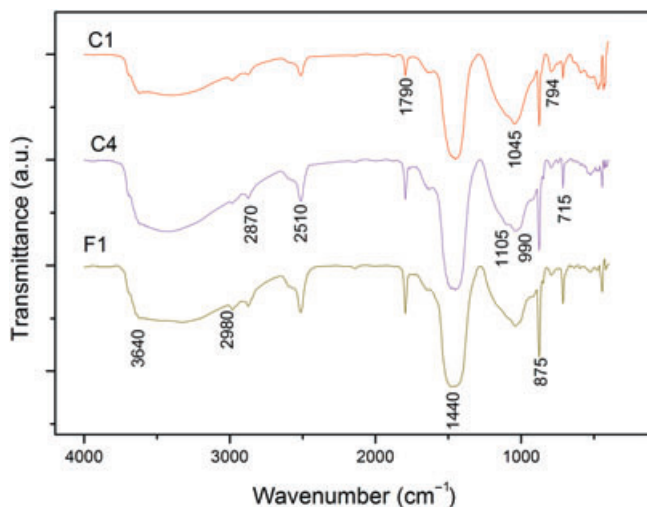
Figure 7 FTIR spectra from samples C1, C4 and F1. The main bands are labelled and related to their corresponding mineral component in the text.

In spite of the fact that FTIR is usually employed to analyse organic compounds, this technique is also useful for characterizing inorganic substances. A qualitative analysis from the characteristic frequencies provides information to identify chemical constituents in a compound. Infrared spectra narrow down the options to a few specific components, if only one or two are present. In addition, a correlation of FTIR and XRD may be very helpful. Figure 7 shows the FTIR spectra from samples F1, C1 and C4. The wide band at 3640 cm^{-1} corresponds to O–H group matching with the presence of water in the samples. The wide form of this band

implies that O–H groups must be forming hydrogen bridges. The bands at 1440, 875 and 715 cm^{-1} correspond to the three different elongation modes of C–O bonds while the bands at 2510 and 794 cm^{-1} are the harmonic vibration of some of those elongation modes. The minor bands at 2870 cm^{-1} and the first overtone at 2980 cm^{-1} correspond to the C–O group from the carbonate ion. The thin and intense band at 1790 cm^{-1} is also associated with the carbonate C–O bond. All these bands allow for the identification of CaCO_3 .

The intense and wide bands at 1105, 1045 and 1018 cm^{-1} which are overlapped, relate to SiO_2 (quartz), which is the main component of sand. The presence of quartz was also confirmed by XRD analysis. The main bands corresponding to albite (1005, 1034 and 1150 cm^{-1}) are overlapped with the bands generated by quartz. The identification of albite using IR was questionable, but possible. The results from XRD confirm the identification of albite.

In FTIR, the intensity of the signals or bands could be directly associated with the concentration of a component in the sample. In fact, this correlation makes it possible to use FTIR as a quantitative analysis technique. But in this case, the overlaps between the quartz and albite signals make it difficult to use this information to determine the concentration of each component in the stucco. However, if a semi-quantitative chemical composition determination is carried out using calcite and quartz standards and the bands at 1440 and 1045 cm^{-1} , corresponding to main IR signals of calcite and quartz respectively, it is possible to obtain an average chemical composition ratio between calcite and quartz (lime:sand) from most of the original stucco samples. The average composition ratio was 2:1, which coincides with X-ray diffraction results.

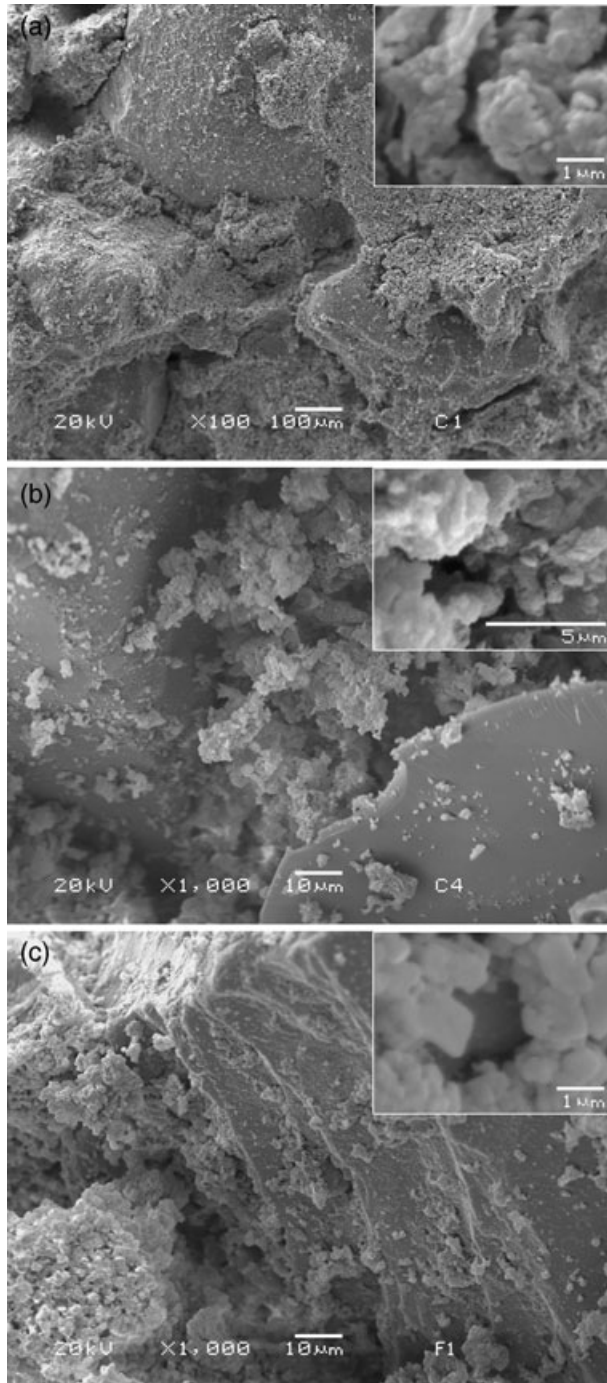
Figure 8 Scanning electron micrographs of stuccos from different building stages. The images correspond to samples (a) C1, (b) C4 and (c) F1.

The observations made using SEM show a superficial layer made of fine powders mainly of CaCO_3 in the samples, see Figures 8 (a) to 8 (c). This layer is the external surface of the stuccos. Below these fine powders, there is a solid bulk made of large particles which has low porosity and does not show cracks or fractures. Most of the boundaries observed among the large particles appear to have good adhesion. The chemical composition of the large particles showed a higher content of silicon and aluminium than that of the fine powders, according to energy dispersive spectrometry (EDS) analysis. The latter results indicate that albite and quartz are the main components of large particles and calcite appears to be more abundant in the small particles. These results also confirm the presence of quartz, albite and lime in the original stuccos. The solid appearances of large particles lead to the assumption that this material could be mechanically resistant. Figure 8 (a) corresponds to C1. The large particles seem to be attached through fine powders as if they were bricks in a wall. Amplification of the fine powders makes it possible to observe a flake-like morphology with well-defined edges, typical of CaCO_3 . Similar morphologies were observed in Figures 8 (b) and 8 (c), which correspond to samples C4 and F1, respectively. The large particles show more defined edges in samples C4 and F1 and they possess a similar appearance to that of ceramic materials.

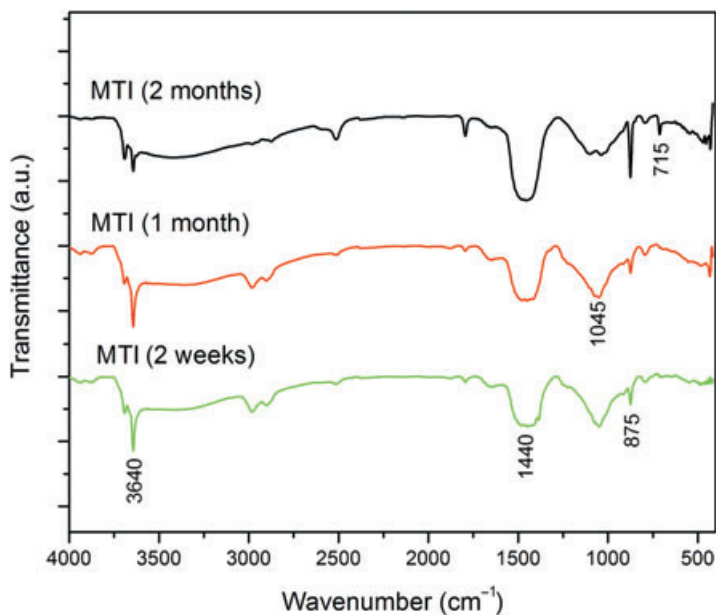
Figure 9 FTIR spectra from new stuccos at different ages. The main signals are labelled to relate to their corresponding mineral components (see text). Notice the relative intensities of the main peaks of calcite and quartz.

was selected which characterizes the analysis that is presented herein. Figure 9 shows FTIR spectra from a new stucco sample at different ages. It is possible to observe how the $\text{Ca}(\text{OH})_2$ was gradually transformed to CaCO_3 . The band at 3640 cm^{-1} corresponding to the O–H group was decreasing its intensity as a function of time. On the other hand, the intensity of the bands at 1440 , 875 and 715 cm^{-1} , related to the carbonate group, increased over time. The band at 1045 cm^{-1} related to quartz (sand) maintained its intensity. If a comparison is made between Figures 7 and 9, it is possible to see that the new stucco aged 2 months is quite similar to those originally taken from El Museo del Calendario.

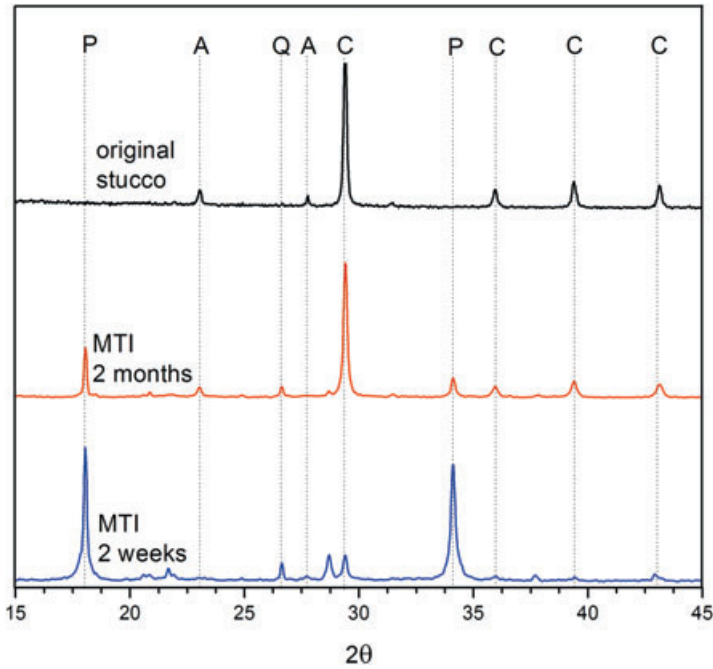
Figure 10 X-Ray diffraction patterns from new stuccos at different ages. Identification of the signals is shown: P, portlandite; C, calcite; Q, quartz; A, albite.

In a similar way, X-ray diffraction of the new stuccos shows several signals corresponding to portlandite (P) and others related to calcite (C). As times passes, the peaks of portlandite gradually decrease in intensity (see Fig. 10 middle and bottom diffractograms). In contrast, the calcite reflections increase in intensity in relation to time. The signals corresponding to quartz (Q) and albite (A) maintained their intensity through time. Some slight changes in those peaks can be observed in Figure 10, this apparent intensity variation is produced by the corresponding change in the relative intensities of the peaks from C and P, since these peaks are the most intense in the diffractograms, and the relative intensities for all signals are normalized compared to the large ones. Once again, if a comparison is made between the diffractogram of an original stucco (Fig. 10, top) and that corresponding to the 2-month-old ‘newer’ stucco (Fig. 10, middle), several similar signals can be found, and this fact supports the suggestion that the new stuccos have a similar chemical composition to the original ones.

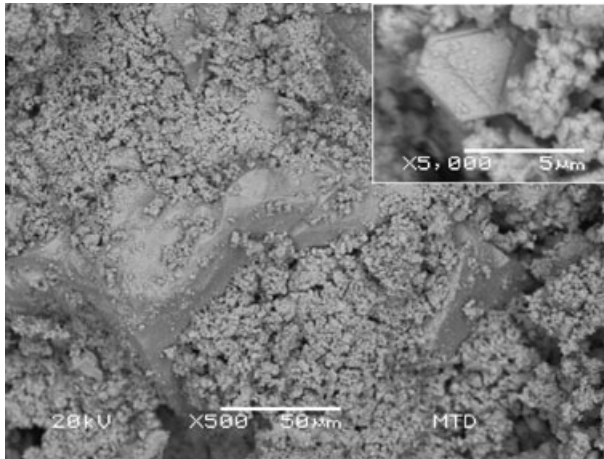
Figure 11 Micrographs of new stuccos showing morphology and microstructure of small and large particles. The inset shows the detailed morphology and crystal growth habits of a large particle with well-defined edges and shape.

results discussed above. A solid bulk found beneath these fine powders was made up of large particles consisting of Si and Al, quartz and albite (Fig. 11). The chemical composition of the superficial layer and the bulk was determined by use of EDS. The portlandite is still present in the new stuccos and it will undergo a chemical transformation to produce calcite as was previously mentioned. If Figures 8 and 11 are compared, a number of comparable microstructural

and morphological characteristics can be found between the new and original stuccos. The large particles have well-defined edges, which are evidence confirming the crystal growth. In addition, the large particles have low porosity, and cracks or fractures were not observed. The morphology of small particles in new stuccos could be a little different from that found in the original materials. This morphological discrepancy is due to the presence of portlandite crystal, but this difference will disappear with the passing of time when most of the portlandite turns into calcite. In general, it is possible to assert that the microstructure and morphology of ancient and new stuccos are quite similar; consequently the macroscopic appearance will also be very similar.
