High-Temperature Corrosion Observed in Austenitic Coils and Tubes in a Direct Reduction Process

The subject of this study is related to the performance of austenitic steel coils and tubes, in a range of temperatures between 425 and 870 °C for the transport of reducing gas, in an installation involving the direct reduction of iron-ore by reforming natural gas. Evidence is presented that metal dusting is not the only unique high-temperature corrosion mechanism that caused catastrophic failures of austenitic 304 (UNS S304 00) coils and HK-40 (UNS J94204) tubes. Sensitization as well as stress corrosion cracking occurred in 304 stainless steel coils and metal dusting took place in HK-40 tubes, a high resistance alloy. The role of continuous injection of H₂S into the process is suggested to avoid the high resistance metal dusting corrosion mechanism found in this kind of installation.

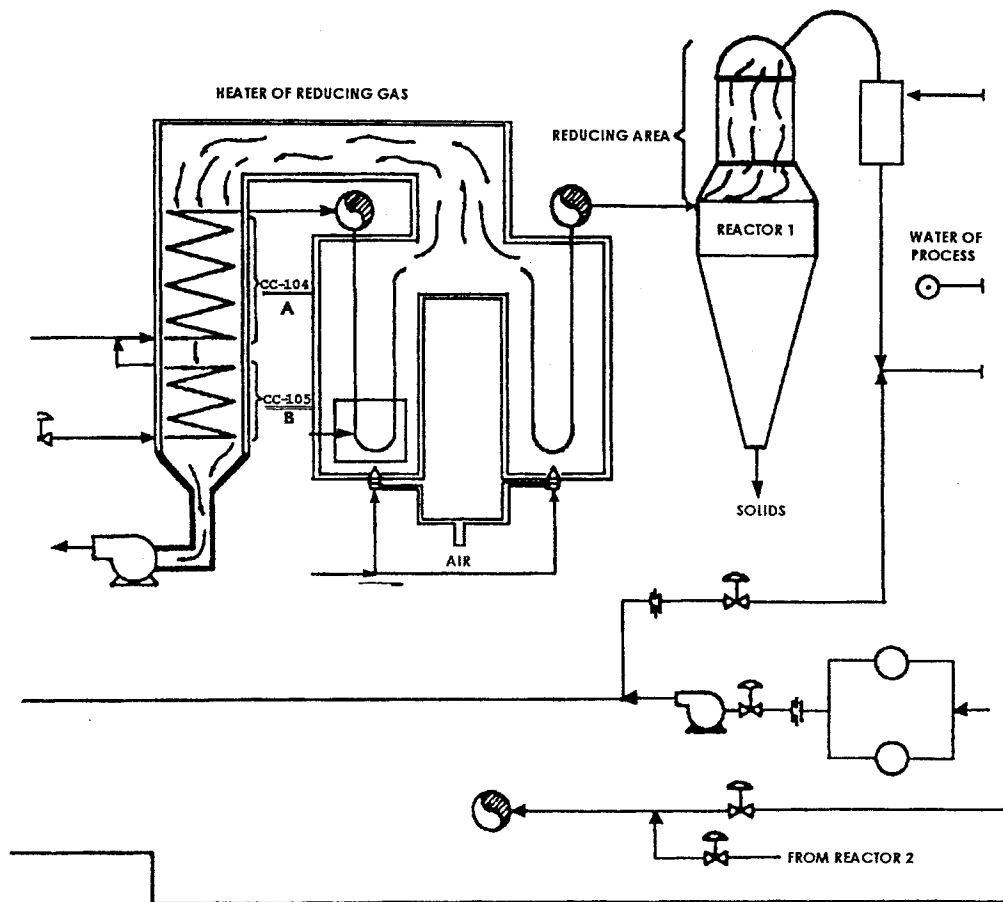
A schematic diagram of heater 3 in the direct reduction process at Ispat is shown in Fig. 1, where 304 stainless steel (UNS S30400) coils were removed after a catastrophic failure occurred in two different locations: (1) in the second stage of the preheating zone of the reduction gases (CC-104); and (2) in the recollection zone of exhaust gases (CC-105). The same diagram also shows the region (marked with a square in Fig. 1), in which a section of a tube of a heat-resistant alloy of the HK40 type was removed after catastrophic failure.

Fig. 1 A section of a diagram of heater 3 of the direct reduction process from which coils (section CC-104 A and CC-105 B) and tubes were removed after catastrophic failures occurred
